## Whats in this newsletter.

1. CYCLONE OLWYN - UPDATE
2. FULL ROOF REPLACEMENTS
3. REPAIRS TO 10A structures

## 1. UPDATE ROOF REPAIRS - CYCLONE OLWYN

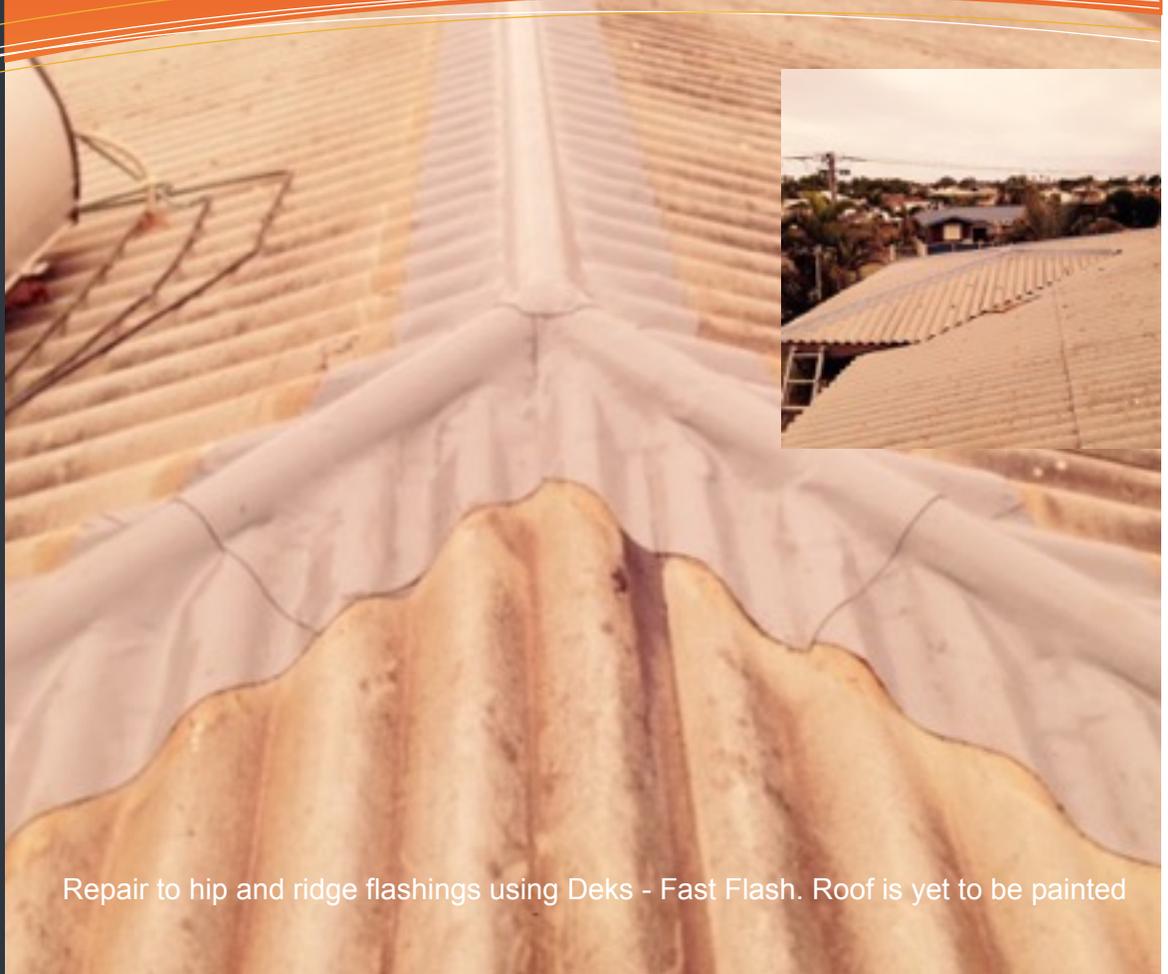
Repair to hip and ridge flashings using Deks - Fast Flash. Roof is yet to be painted

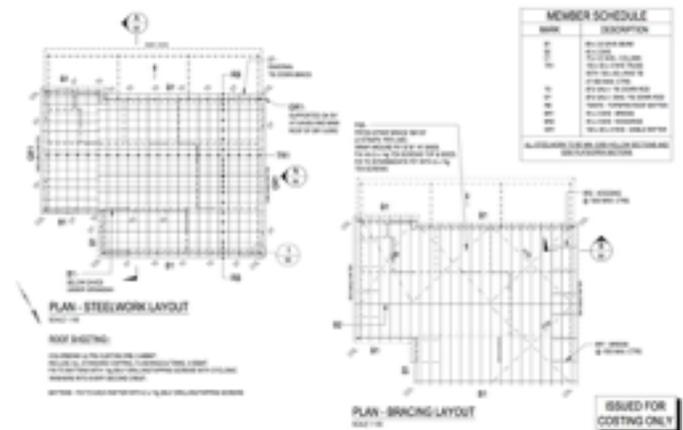
With replacement, the design had to consider and include:- cost, build-ability, scope creep, and especially OHS issues, including:- minimising the removal, exposure and handling of the Asbestos. With some consideration, NWC designed a canopy styled roof, that meets the Building Code of Australia (BCA) and reduces the cost risk to all stakeholders. By including new materials in the roof design, there is a clear delineation in the construction which is easily supervised, installed and manufactured.
