## Whats in this newsletter.

1. CYCLONE OLWYN - UPDATE
2. FULL ROOF REPLACEMENTS
3. REPAIRS TO 10A structures

## 1. UPDATE ROOF REPAIRS - CYCLONE OLWYN

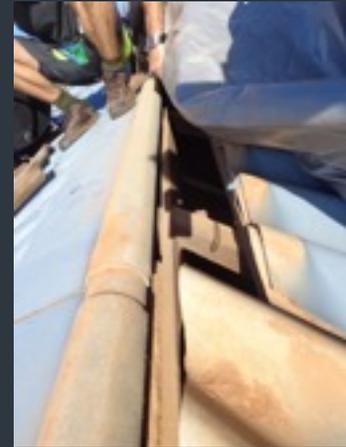
Repairs are currently commencing in Carnarvon and North after Cyclone Olwyn, with over 180 buildings surveyed by NWC, less than 10% of the homes required new roofs. Most of the repairs were damaged fencing, damaged hip and ridge flashings to homes and individual sheet removal and replacement. On review of the Australian Standards, discussions with the Building Commission of WA, Shire of Carnarvon, Insurance repairers, Insurers and the Assessors we quickly established that there were only two options available, either repair or replace. Since 80% of the homes in Carnarvon are ACM and 80% of the damages were minor damage to hips and ridges, various repair methods were reviewed. Repair methods included the use of Colorbond flashings for replacing ridges and hips, unfortunately this product relies on metal fixings and a large amount of sealants. After viewing the result of previous repairs, particularly the level of corrosion and being so close to the coast (less than 1km in most cases), achieving a warrantable water tight finish was going to be an issue. Deks, a specialist supplier of water proof fixings had released a product called "Fast Flash", and on testing the 560mm wide product, this was found to be an economically sound solution. Benefits included : - able to profile to the existing roof sheets, able to be painted, a 20 Year warranty, no metal fixings exposed to the salt, with the profiled roof sealed water tight. The above photo is the Deks product used in Carnarvon, (prior to painting), ridge profiles are provided by using 80-100mm PVC pipe formers under. (Photo supplied by Zinclad)
